# Vinotemp VT-12TEDi Motherboard Repair

Remove the motherboard (and connected heat sink) for repair or replacement.

Written By: Jeff Snyder

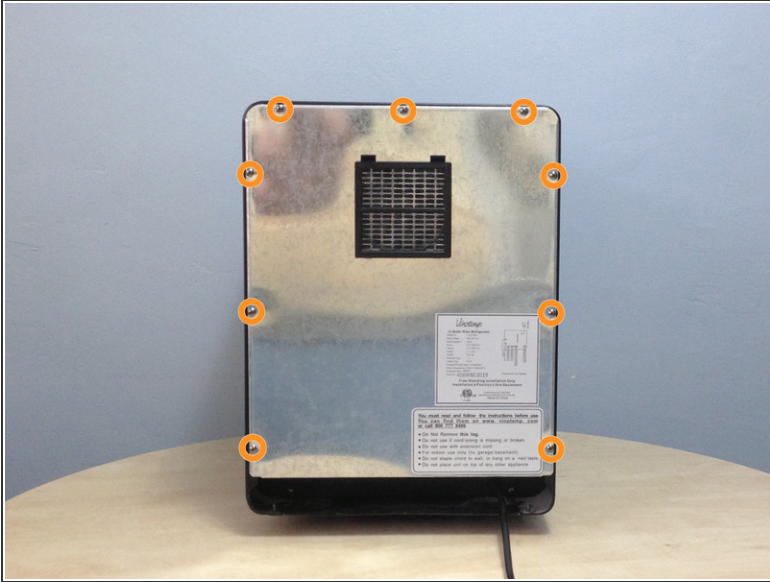
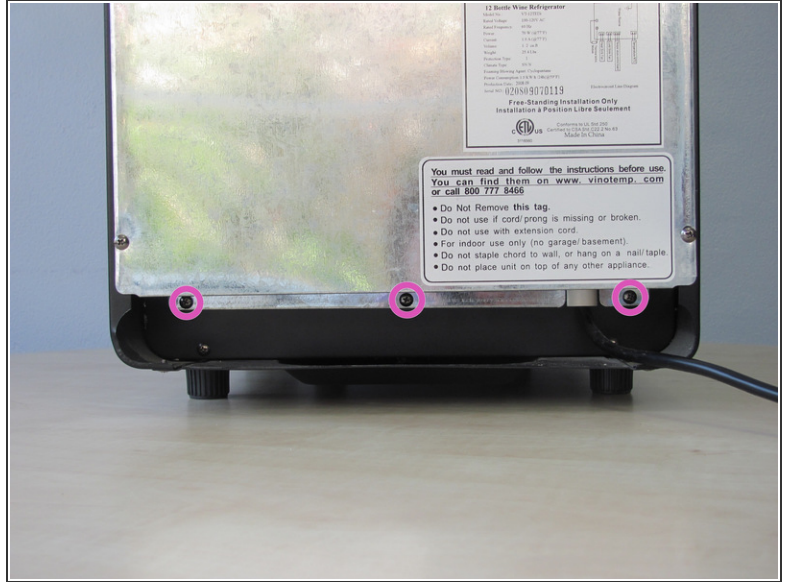
## Step 1 — Power Cord

- Remove nine 12mm Phillips screws from the upper back panel.
- Remove three 12mm Phillips screws inset under the back panel.

⚠ As soon as the screws are removed, the panel will fall freely.

ⓘ When replacing the twelve 12mm Phillips screws, do not tighten the fasteners until all twelve screws have been loosely fitted back onto the cooler. This will ensure the flimsy metal casing will not warp.

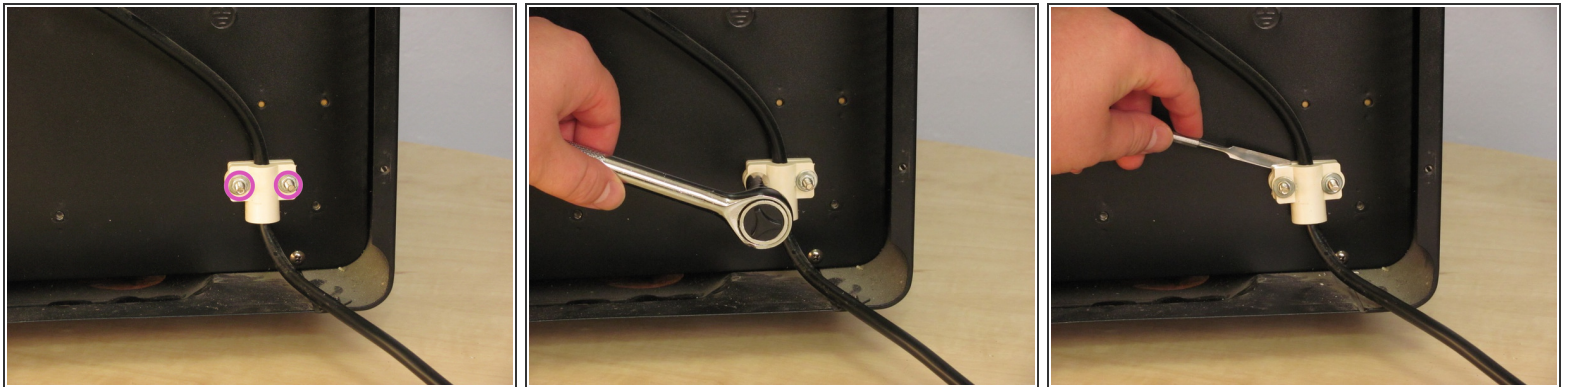
## Step 3

- Remove two 7mm Hex Nuts.

Clearance is minimal and these screws are very tight. You will likely need a socket wrench to avoid stripping.

If the white plastic components stick, pry them apart with a metal spudger. Don't pull on the power cord to get plastic pieces to separate.

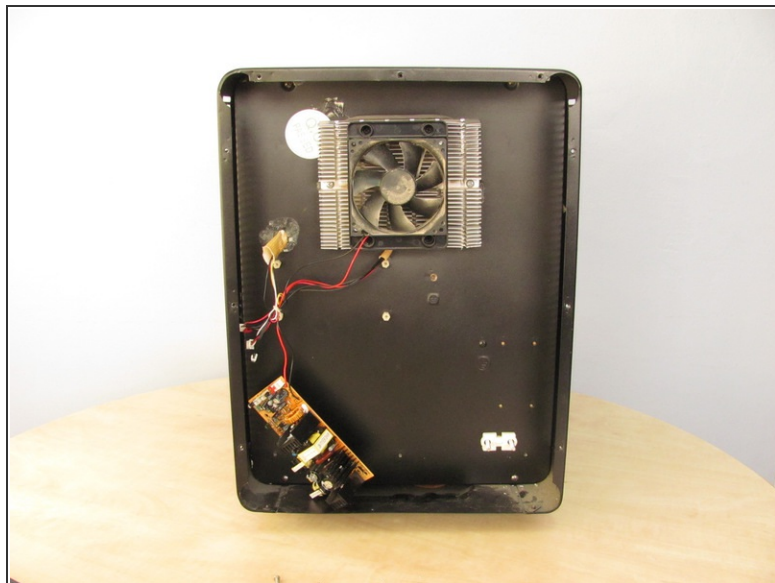
## Step 8

- Remove four 12mm Phillips screws.

⚠ Once the four Phillips screws are removed, the motherboard will dangle there until you remove the heat sink. Be careful.
